Bioremediation of Railadevi Lake in Thane City, Maharashtra

The Railadevi lake bioremediation project was funded by Ministry of Environment and Forest (MoEF), Government of India.

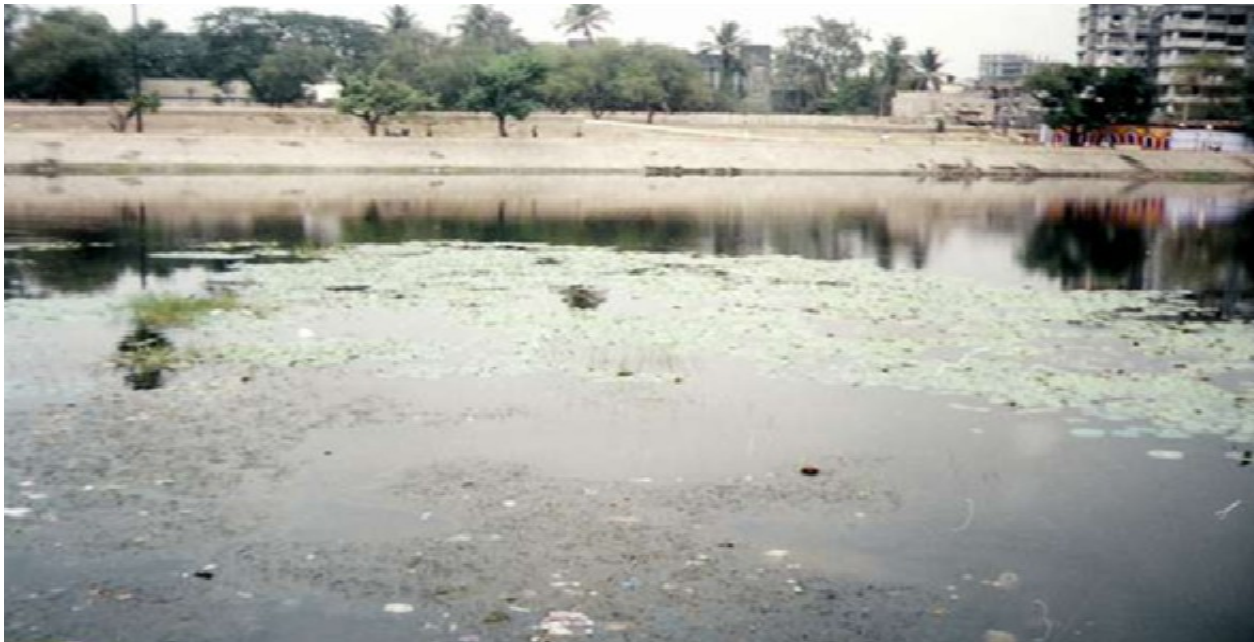
Fig 2: Condition of Lake Railadevi – year 2003

The project was undertaken in the mid of year 2003. The lake was in eutrophic conditions, before starting the remediation process. Due to heavy onslaught of manmade pollution the lake had turned eutrophic. Algal blooms were yearly affair and heavy sludge deposits had blocked the natural springs

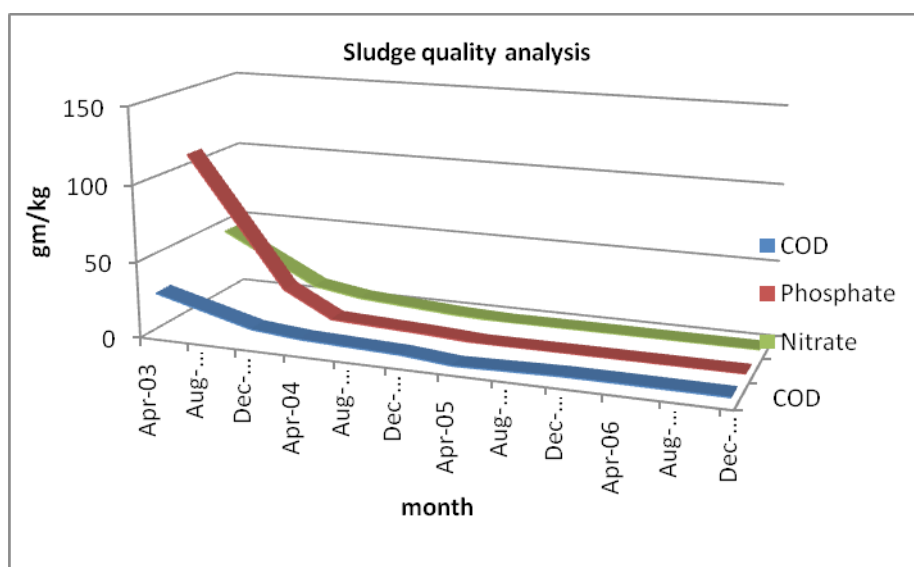
Graph 3 : Sludge quality analysis of Railadevi Lake before and after bioremediation

COD	gm/kg	26	9	6.1	3.8	0.8	2.4	2.4	2.1
Phosphate	gm/kg	108	22	5	2.08	0.064	0.145	0.122	0.112
Nitrate	gm/kg	44	11	5.8	1.32	0.084	0.217	0.134	0.124
